HAWAII DEEP WATER CABLE PROGRAM  
BOTTOM ROUGHNESS SURVEY OF THE  
ALENUIHAHA CHANNEL

HAWAIIAN DREDGING & CONSTRUCTION CO.

MAKAI OCEAN ENGINEERING, INC.  
ED NODA & ASSOCIATES  
HAWAII INSTITUTE OF GEOPHYSICS

May 1, 1986

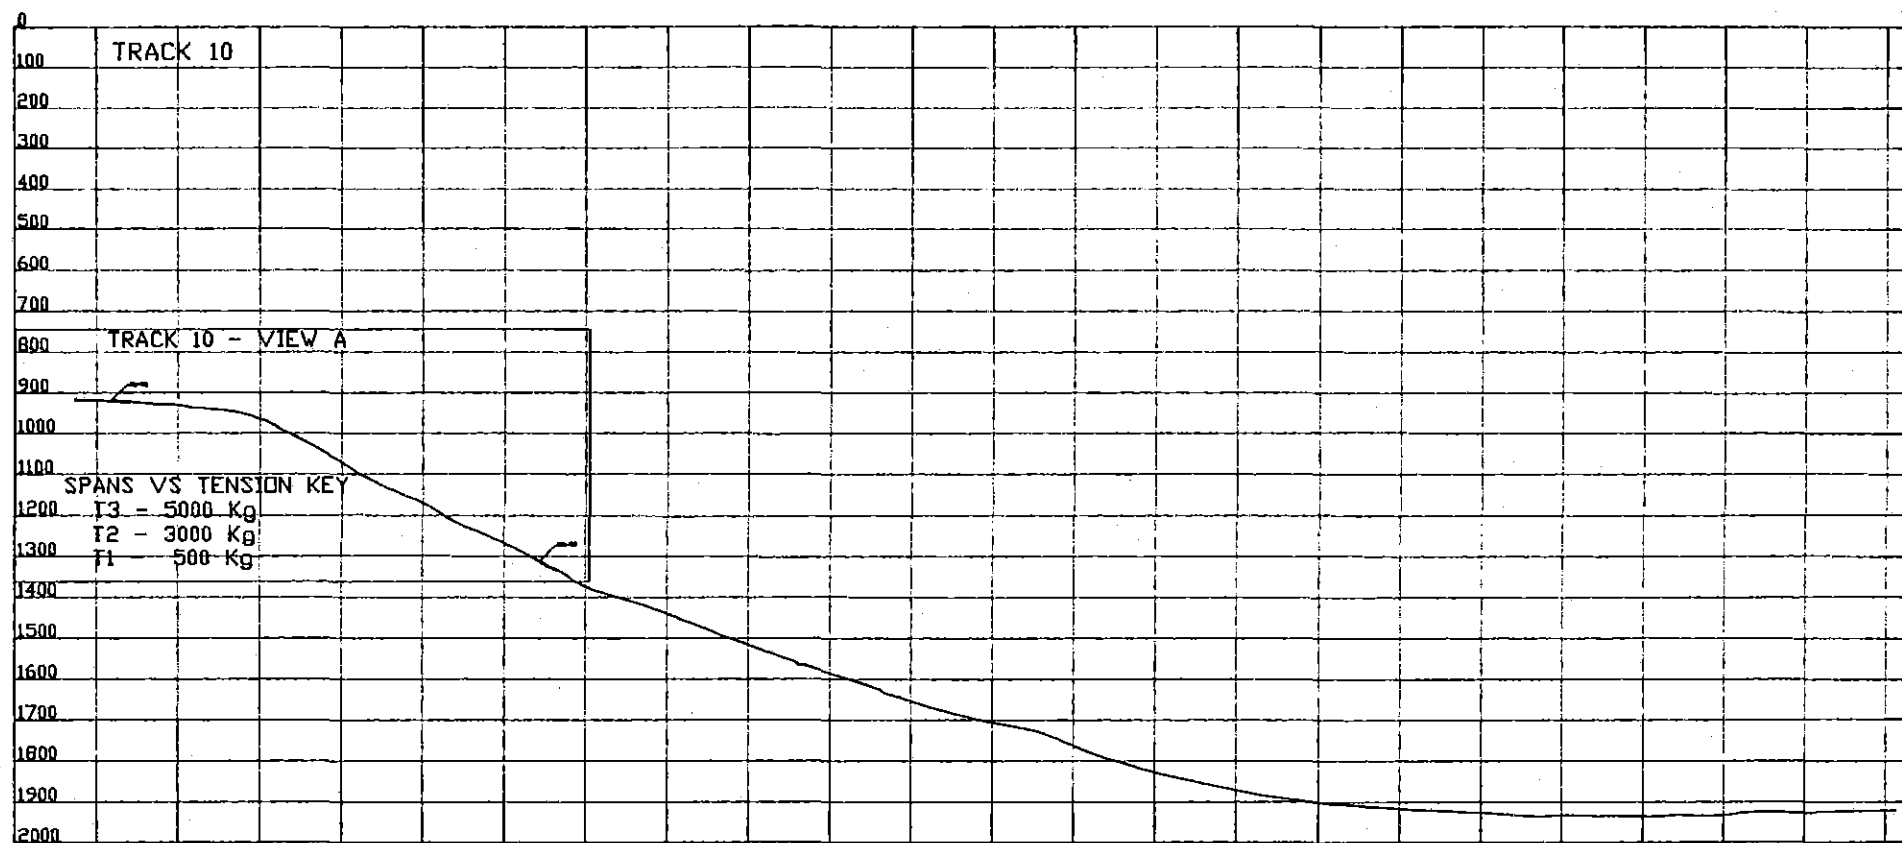
Figure 26

After similar analysis, Track 10 also emerges as a relatively smooth track (see Figures 26, 27). The only critical spans evident arose at a tension of 5000 kg. Analysis at 3000 kg shows no critical spans or bend radii. The only observable characteristic features are two moderate undulations, approximately 50 m long and 5 m deep, which produce critical spans at the 5000 kg tension. The relative smoothness of track 10 is somewhat corroborated by Track 24 (see Appendix), which was nearly parallel to, and following Track 10, although beginning and ending at shallower depths. Track 24 shows two similar undulations as Track 10, at approximately the same depth. Additionally, however, Track 10 shows the emergence of a much rougher escarpment which correlates well with further easterly tracks of increasing roughness.

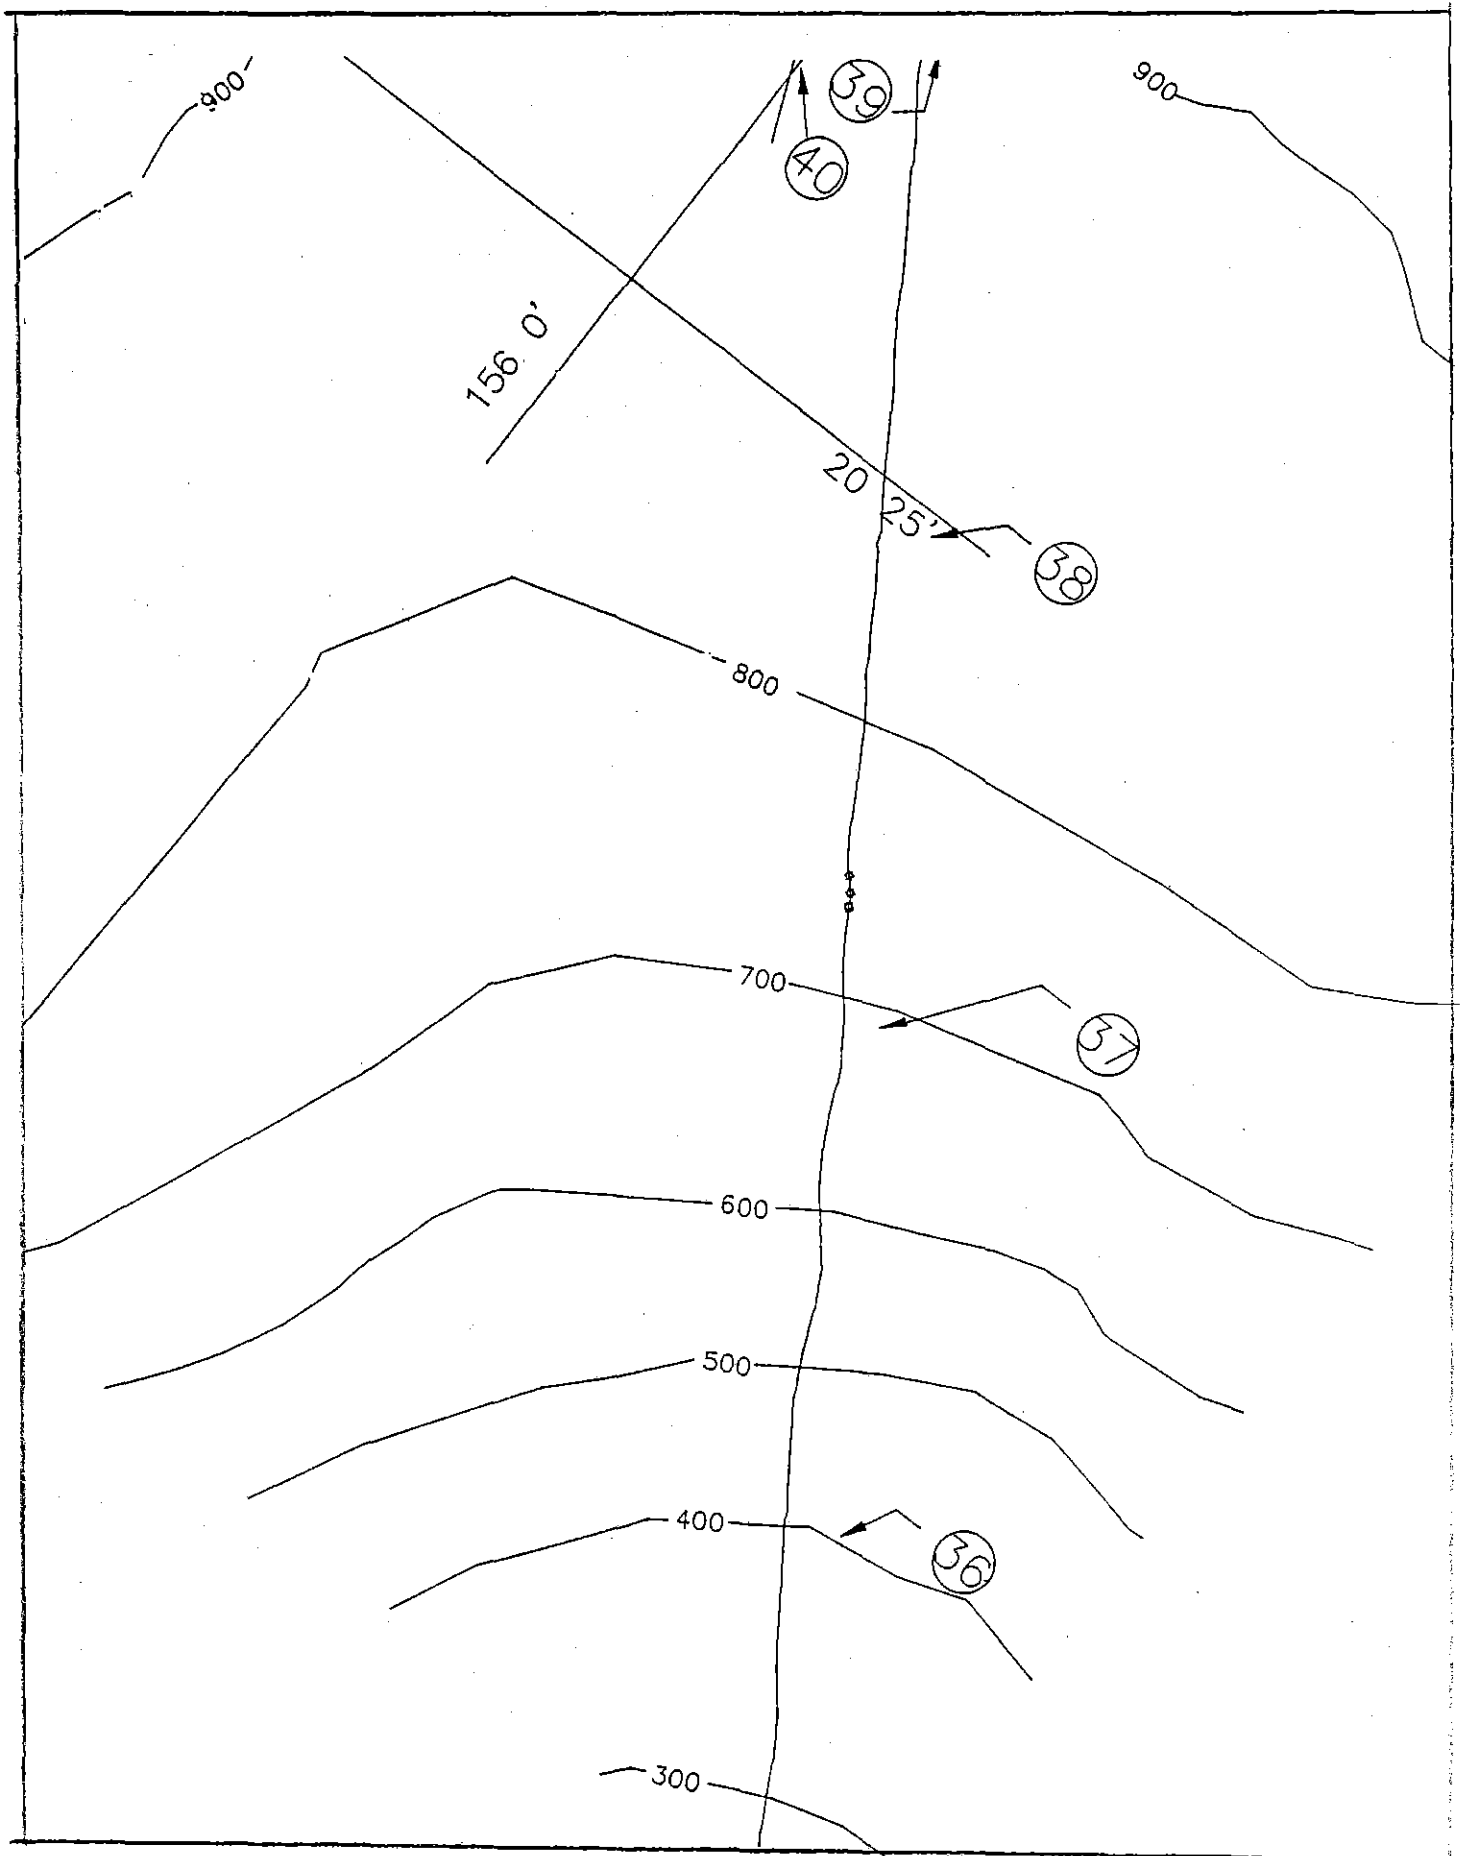
Figure 38

An extended series of tows were made, (Tracks 35 through 38) in the shallow region of the Alenuihaha Channel on the Hawaii side (Figure 38). In other shallow regions on the island of Hawaii old coral reef structures create significant underwater obstacles. For this particular series of tracks, the vast majority of the bottom was fairly smooth. Some regions of rock outcrops occur between 700 and 800 m depth (Track 37) and between 300 and 400 m (Track 35). Most of these obstacles are felt to be isolated ones and can probably be avoided by taking parallel tracks. In this region there is a wide range of maneuverability possible since the channel saddle no longer restricts the route.

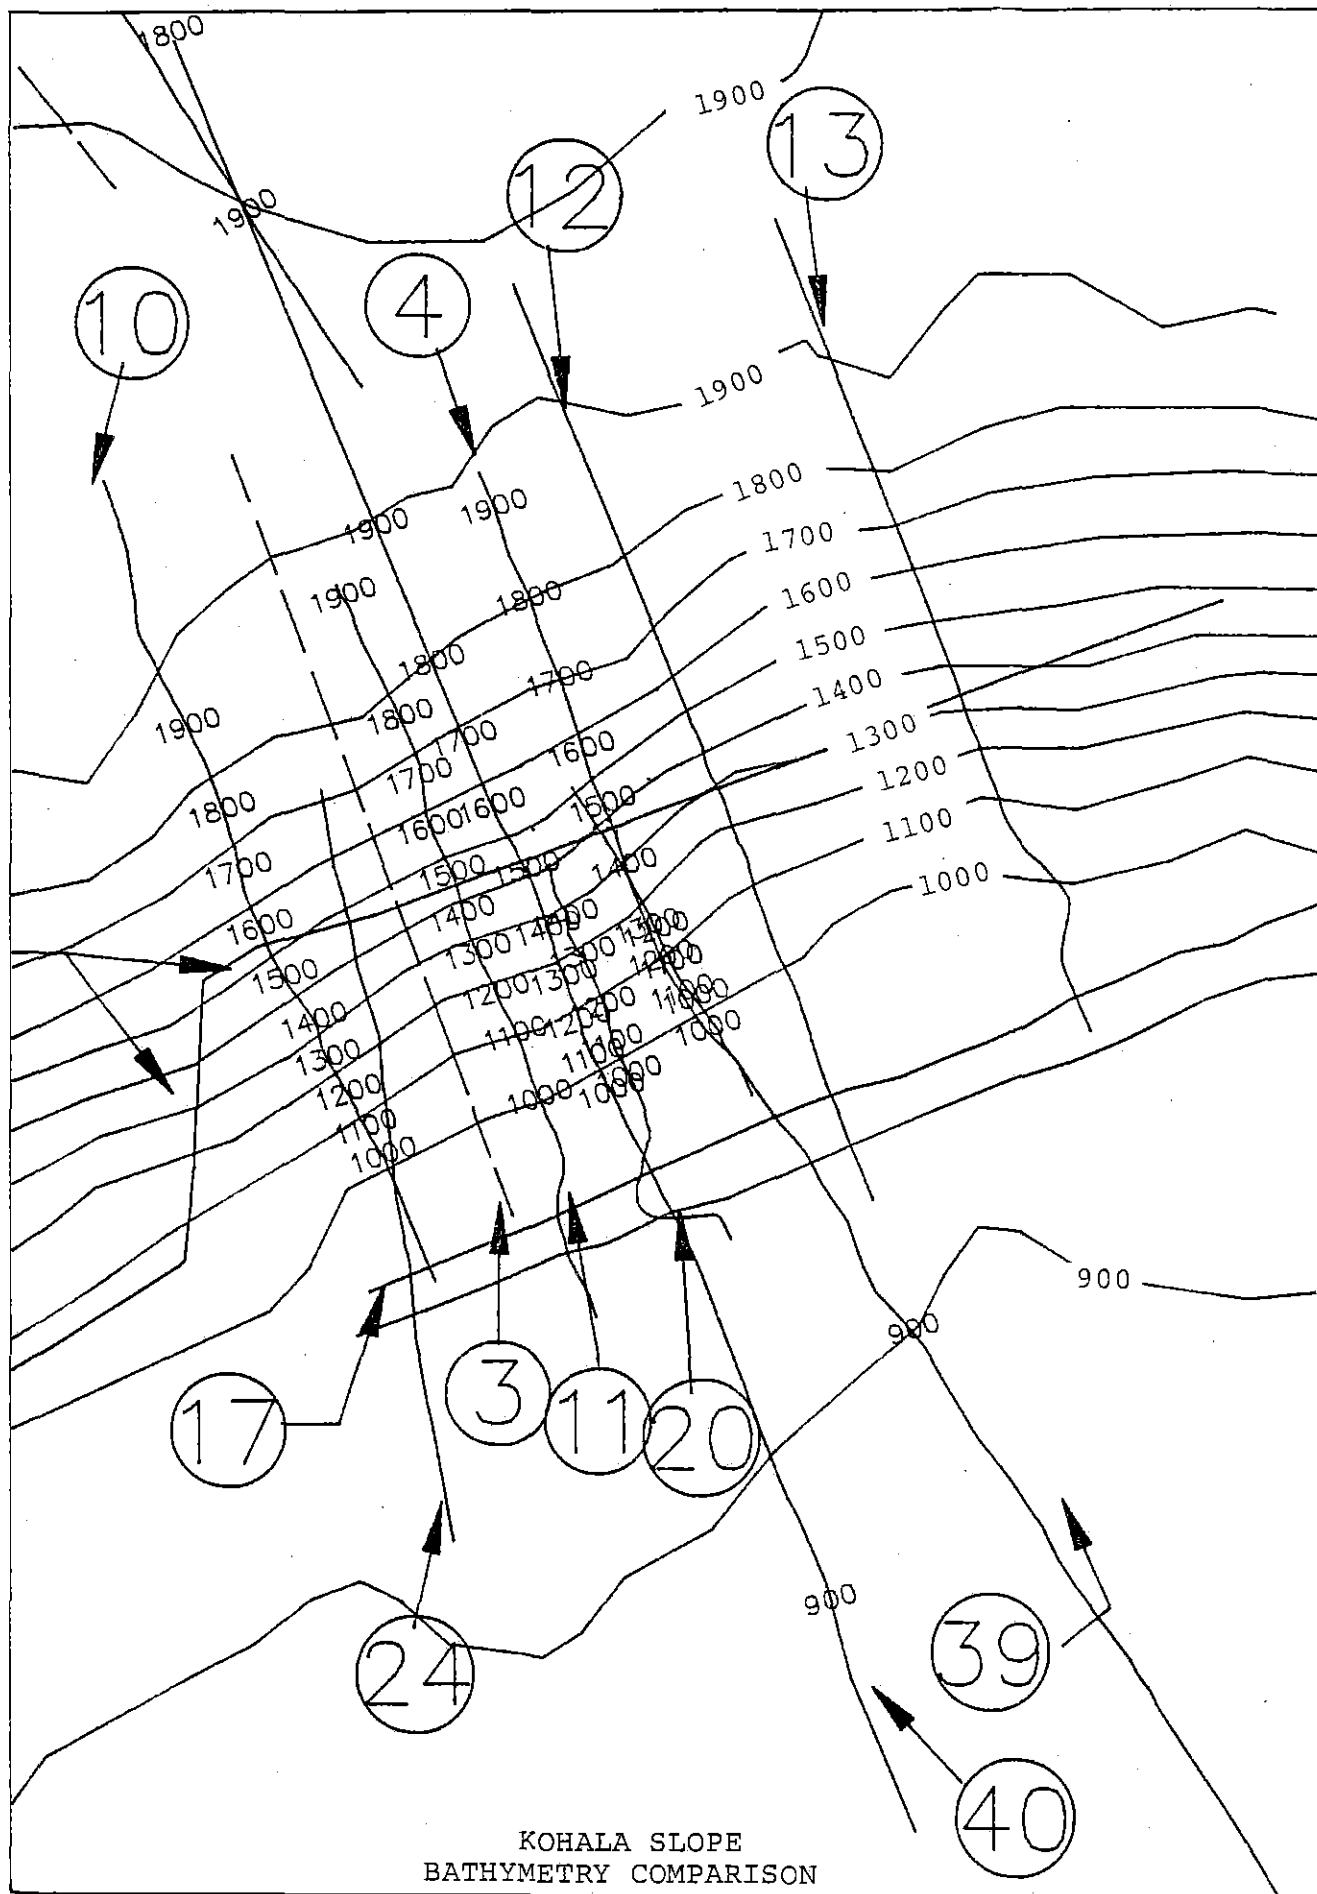
Figure 39

The BRS was located relative to the tow ship, as described previously. The profile data was therefore available in an X, Y, and Z format. The 100 meter contour marks were then determined along each survey profile, and plotted in a plan view for selected profiles. This is shown in Figures 39 and 40, for the Kohala slope area and the Maui slope area respectively. Agreement is seen in a comparison of profile contour marks with NOAA bathymetry on the Maui slope (Figure 40). Most profile contour marks agree within 100 meters of NOAA contour lines. On Track 45, however, contour marks show two major escarpments at the 1100 and 1400 meter levels that do not show up in NOAA contour lines. These escarpments may be localized enough to only show up in the BRS survey, since they do not show up in the nearby Track 21.

The results of the BRS positional corrections can be evaluated by comparing overlapping BRS tracks. Such an evaluation can be made by examining the 100 meter contour marks in the area between tracks 4 and 11 along the Kohala slope (Figure 12). The contour marks generally cluster on the upslope side of the corresponding contour lines, ranging up to 100 meters away, until the slope flattens out. The contour marks of other overlapping tracks agree very well with each other also. This is seen in tracks 20 and 40 which agree to within approximately 50-75 meters, and again in tracks 4 and 39, which agree to within 75-100 meters. The discrepancy between these contour marks is somewhat variable, due to the nature of the correction which is a function of depth and velocity, but it is sufficiently accurate to identify areas of roughness.

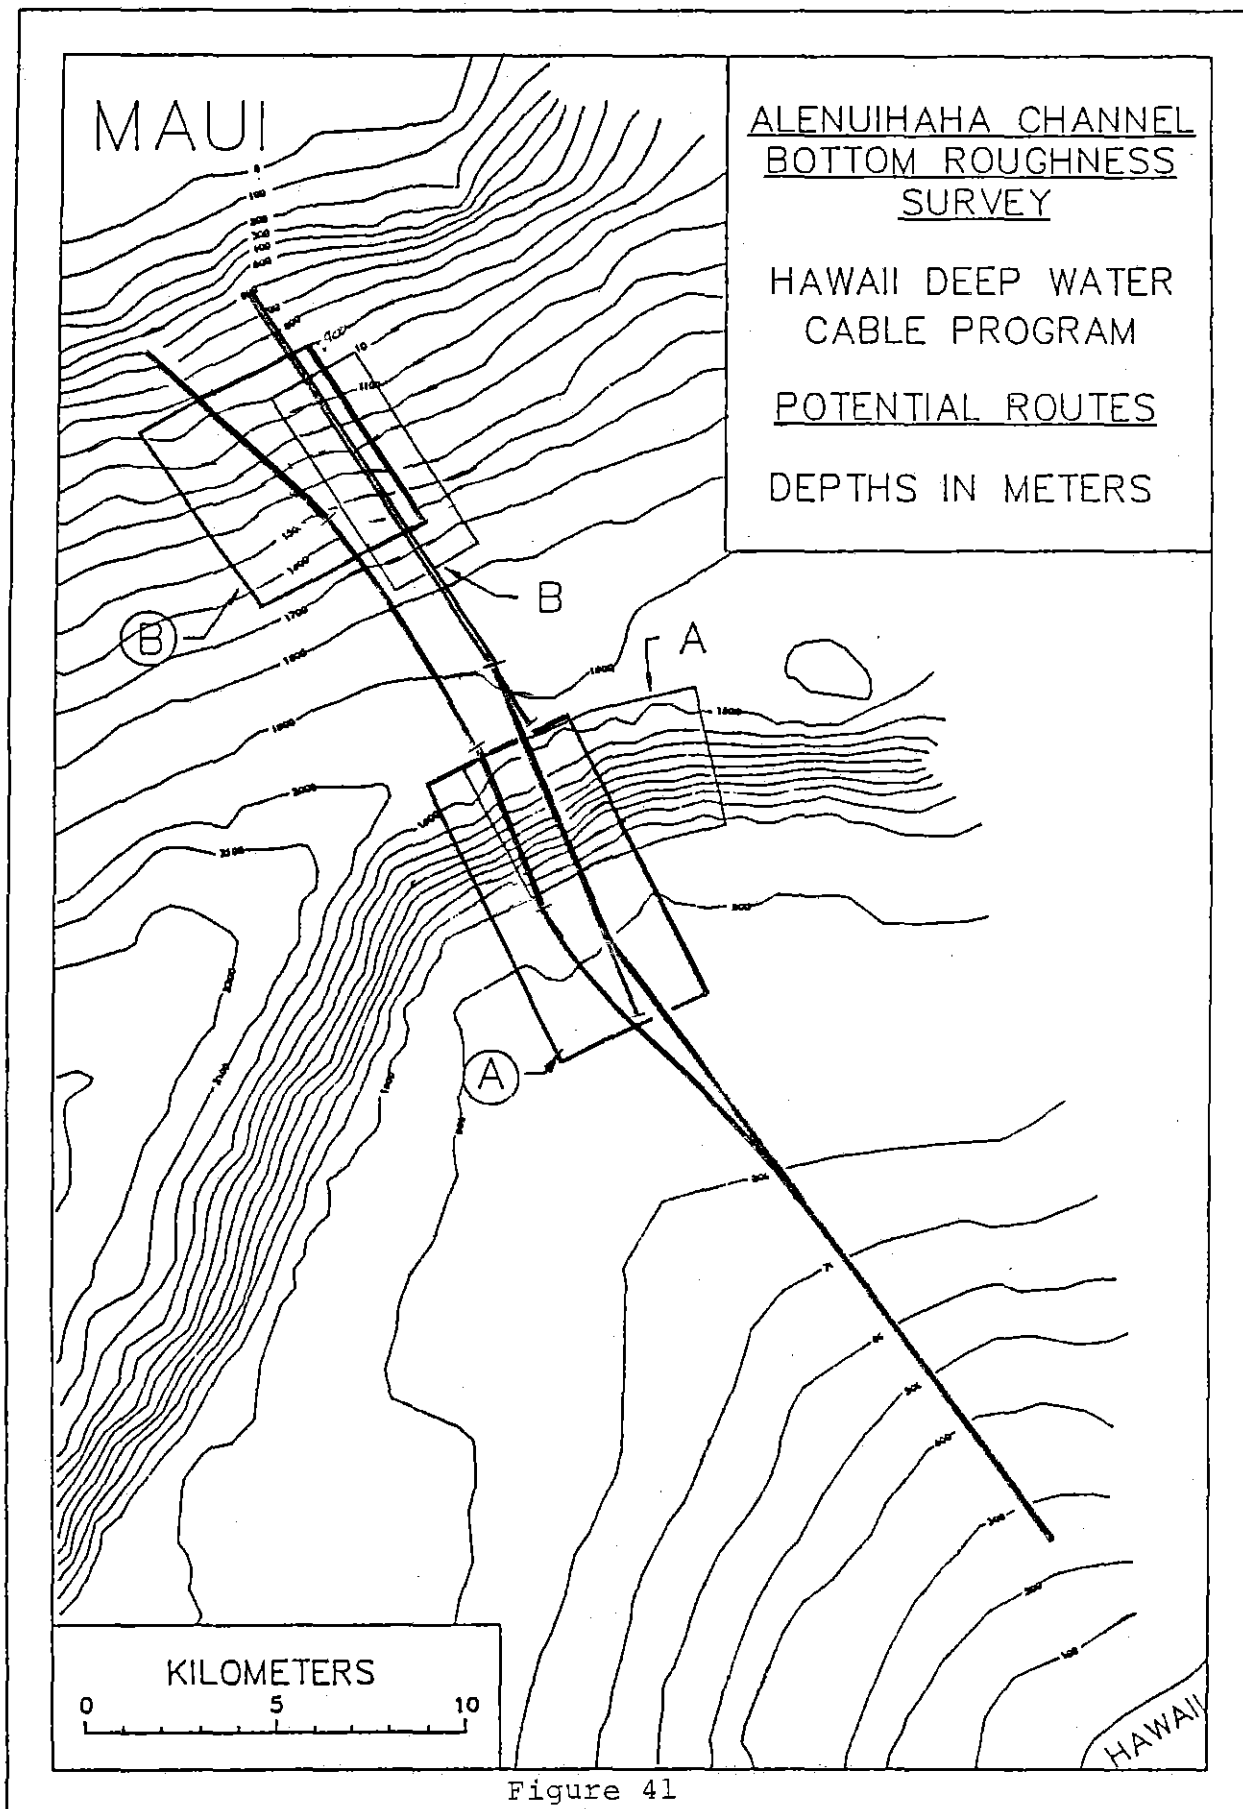
Figure 41 illustrates the recommended areas for further surveying. Areas A and B have been shifted slightly to the west and individual routes, based both on the BRS and the SeaMARC data are suggested. These recommended areas are based on the following:

1. The bottom and the shallow regions above 900 m on both sides of the channel do not appear to present a significant obstacle to the HDWC cable nor does it represent a significant challenge in determining the commercial cable feasibility. Although a specific route has not been identified, it is believed that a route can be easily found across these areas.
2. The mid water depth areas on both sides of the channel are the most significant challenge to the ability to lay the Hawaii cable. The feasibility of laying the cable cannot be addressed without looking further at these areas.
3. The recommended paths through areas A and B are based on the most promising BRS survey tracks and the SeaMARC data showing areas of potential paths.

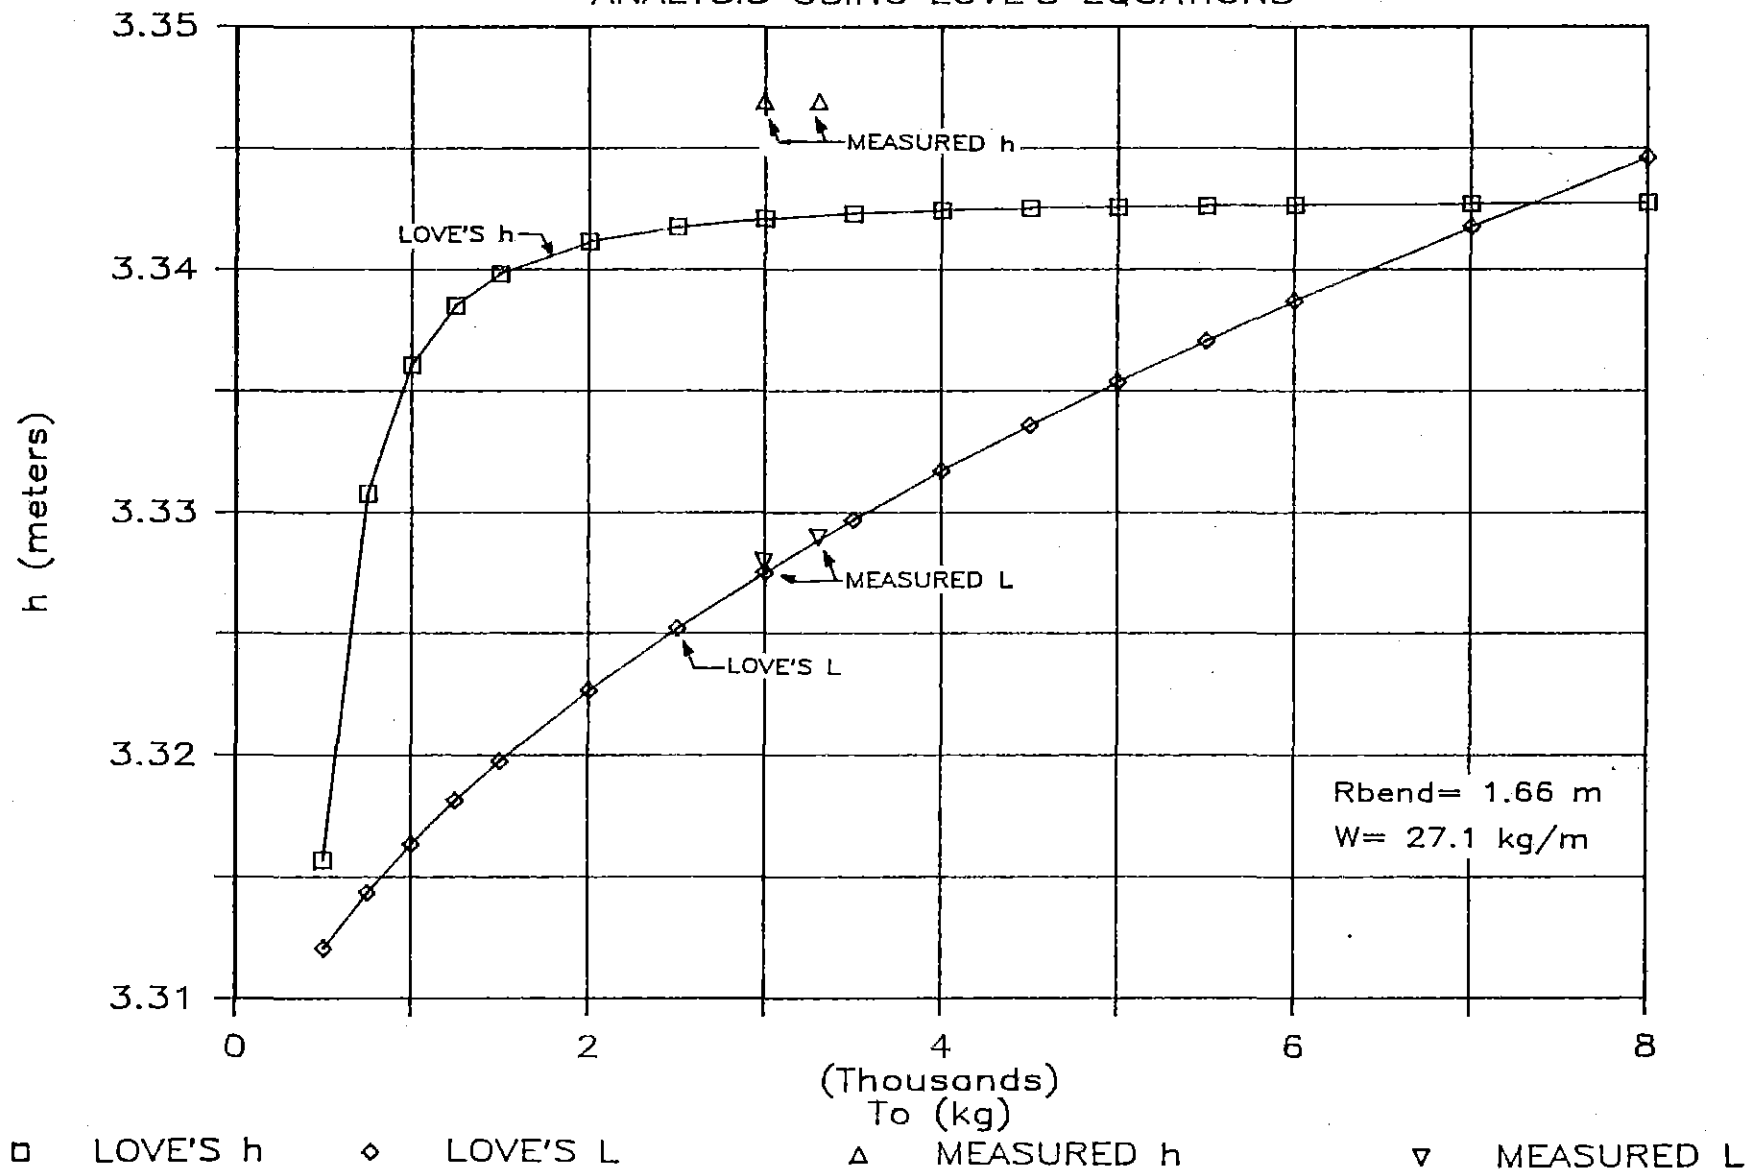
FIGURE E.3

# OBSTACLE HEIGHT AND SPAN LENGTH vs. TENSION

ANALYSIS USING LOVE'S EQUATIONS

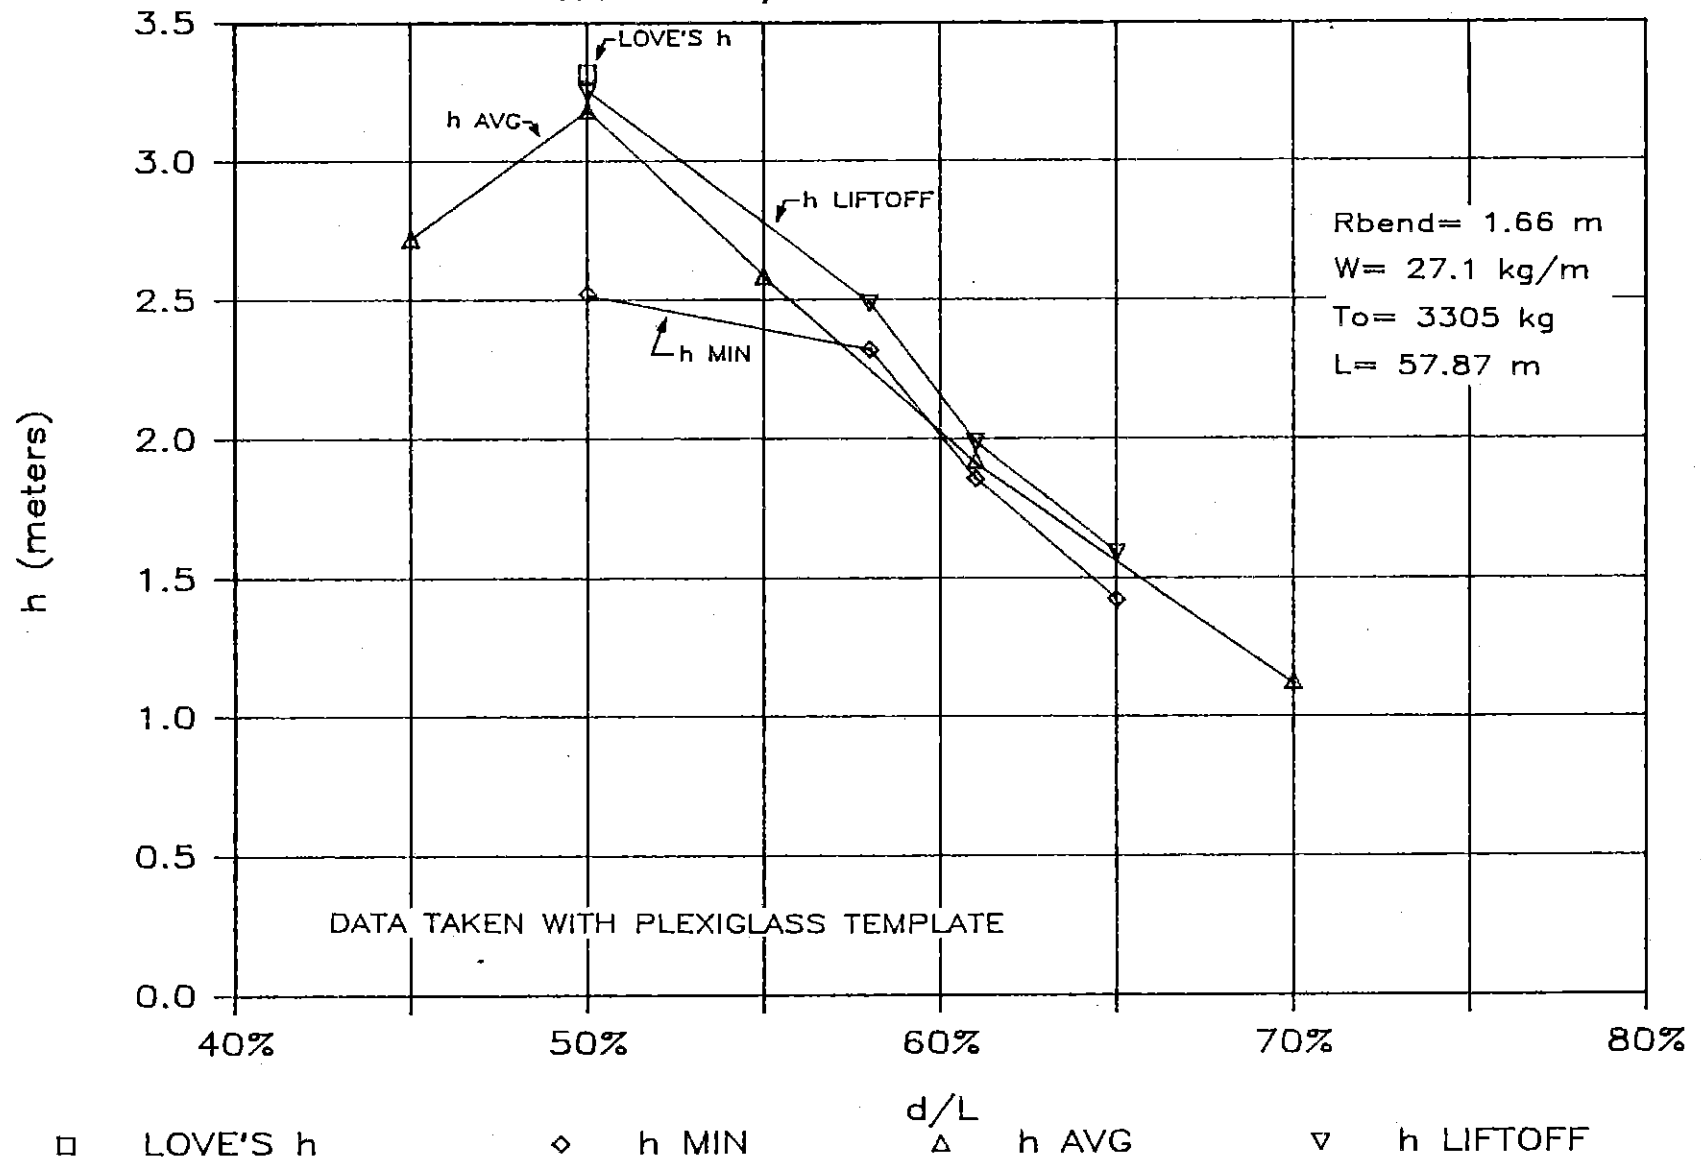
Figure E4

# OBSTACLE HEIGHT vs. SYMMETRY

NO SLOPE, TOUCHDOWN POINTS FIXED

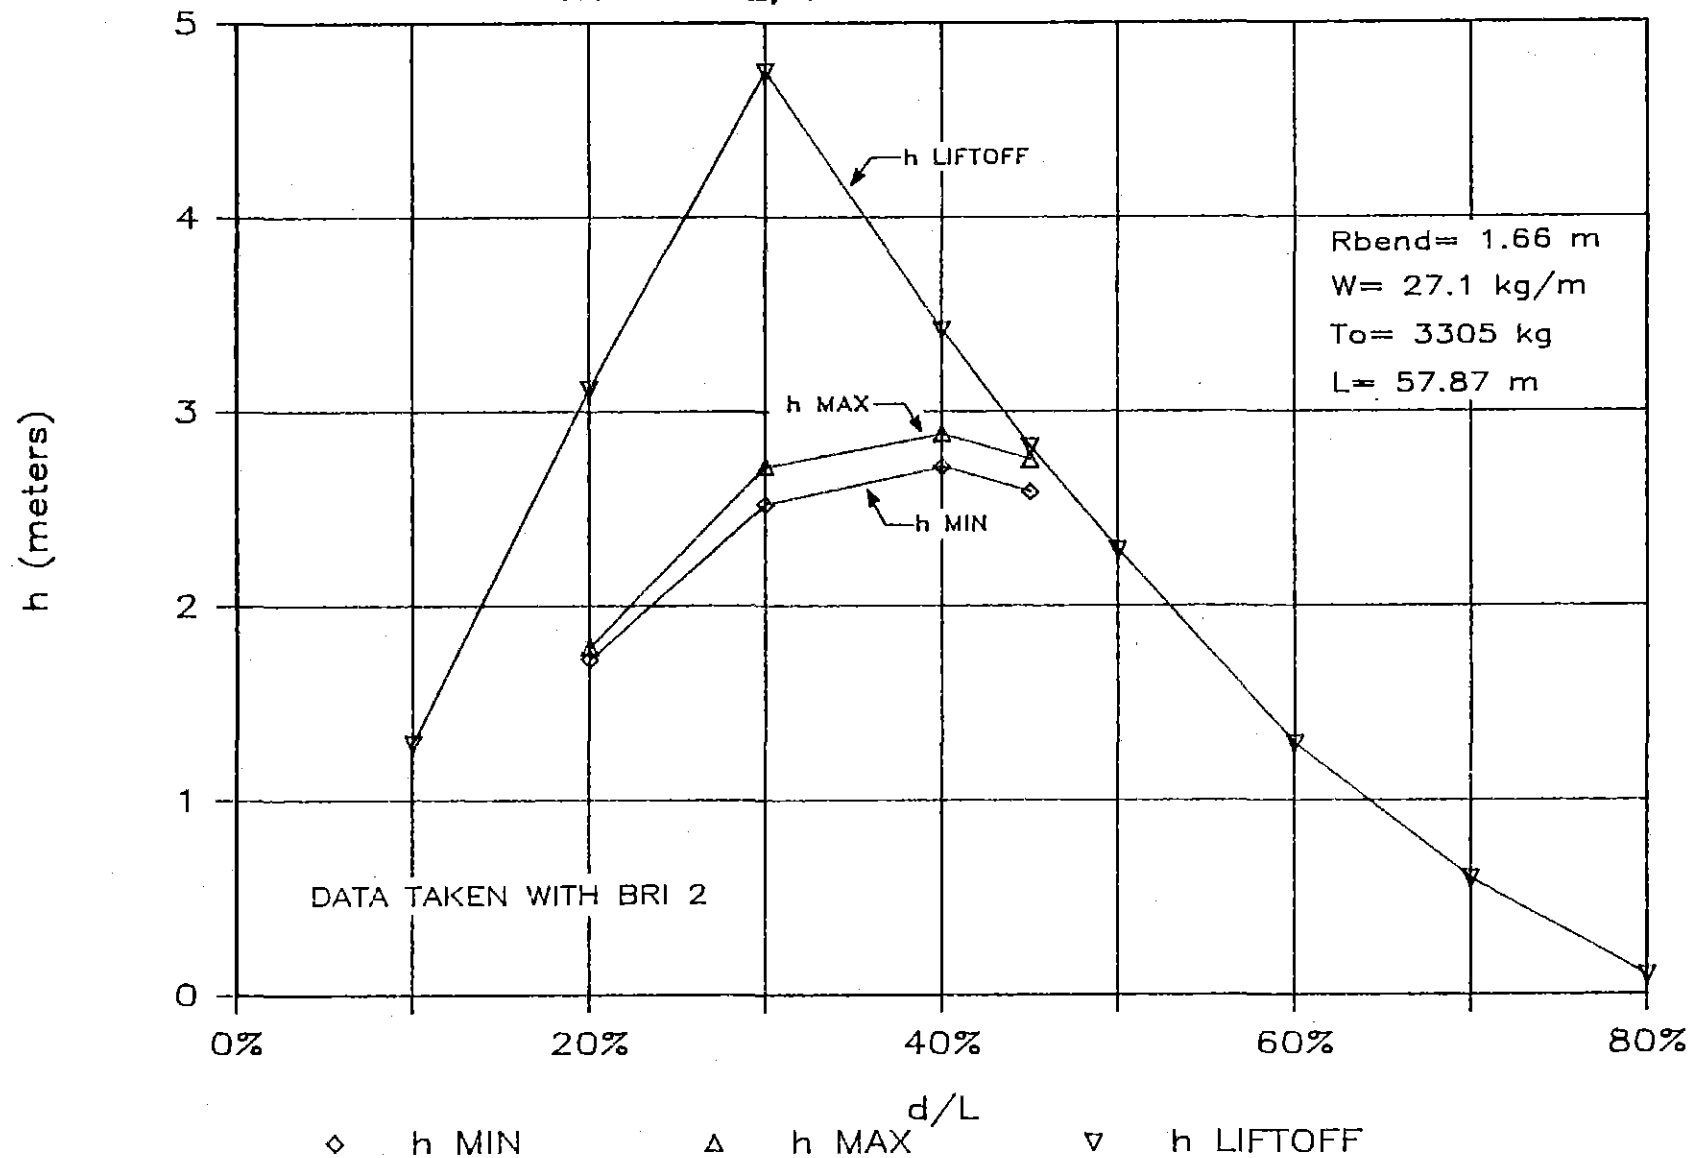
Figure E5

# OBSTACLE HEIGHT vs. SYMMETRY

12° SLOPE, TOUCHDOWN POINTS FIXED

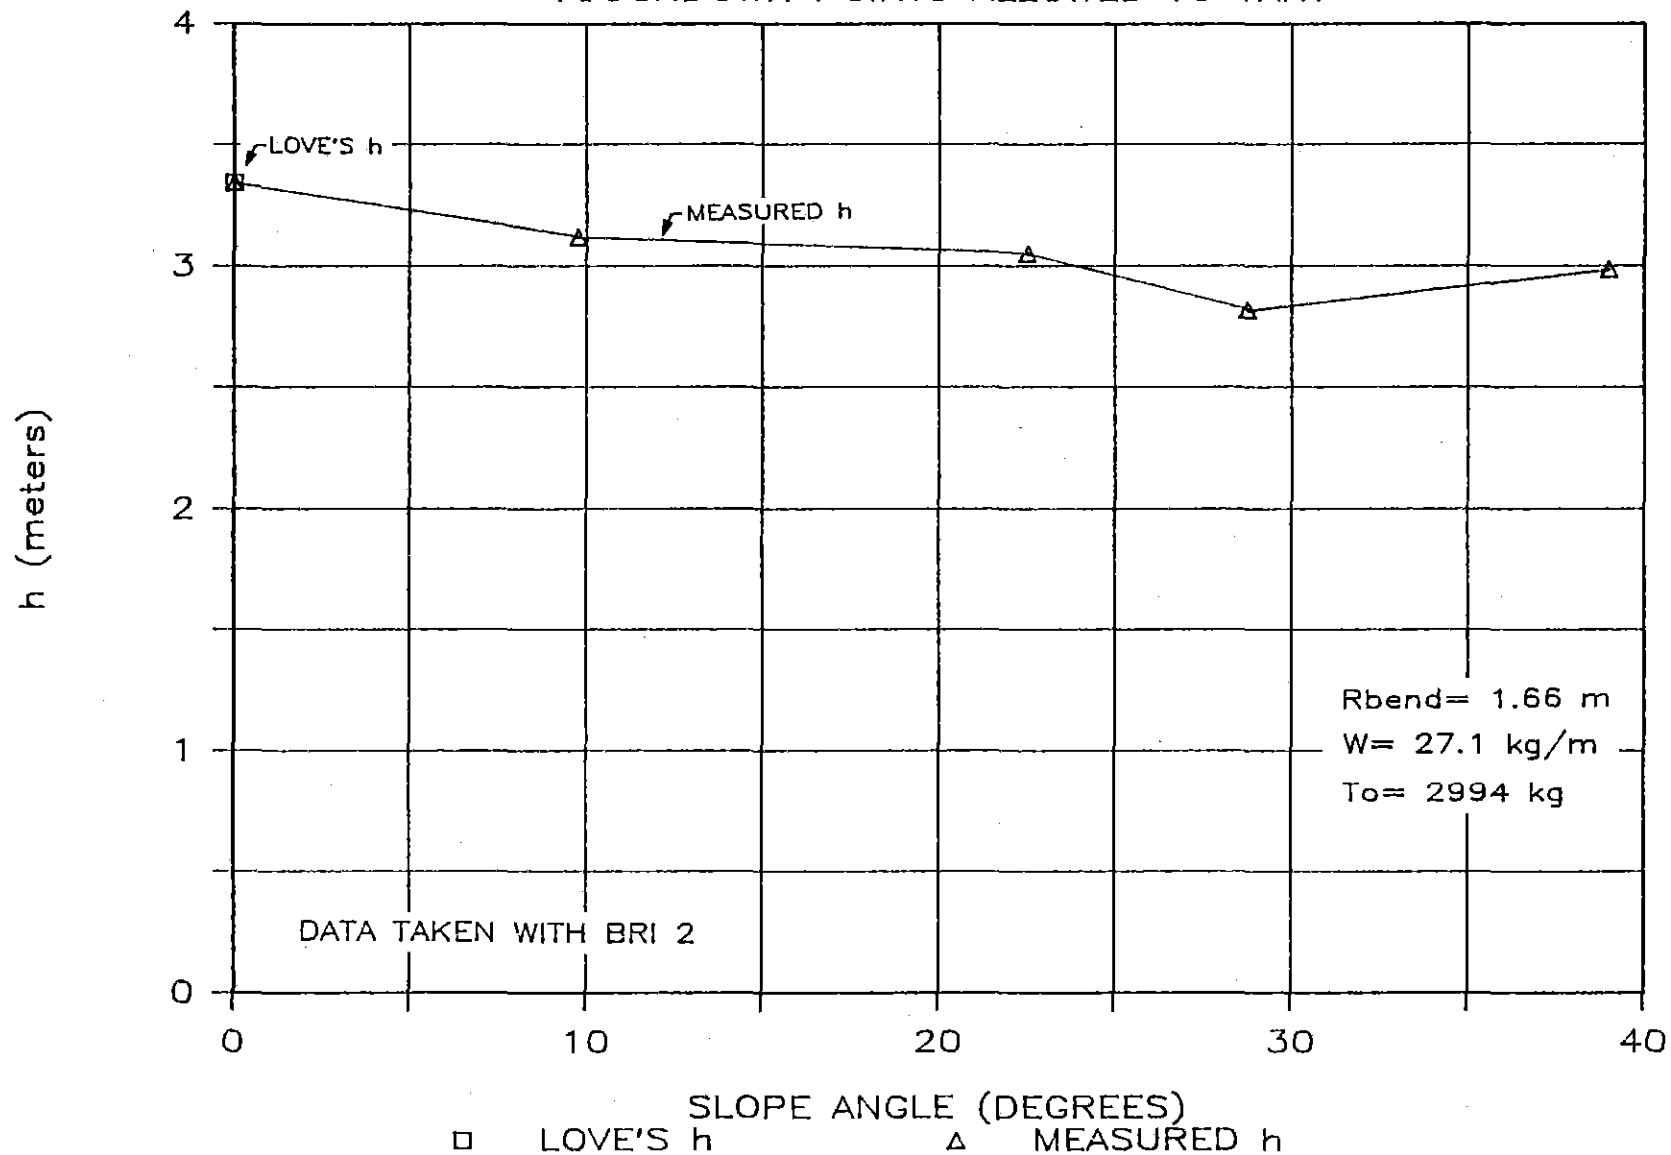
Figure E6

# OBSTACLE HEIGHT vs. SLOPE

TOUCHDOWN POINTS ALLOWED TO VARY
